RC
1042
.M38
1990a
c.2

Department
of Transportation
National Highway
Traffic Safety
Administration

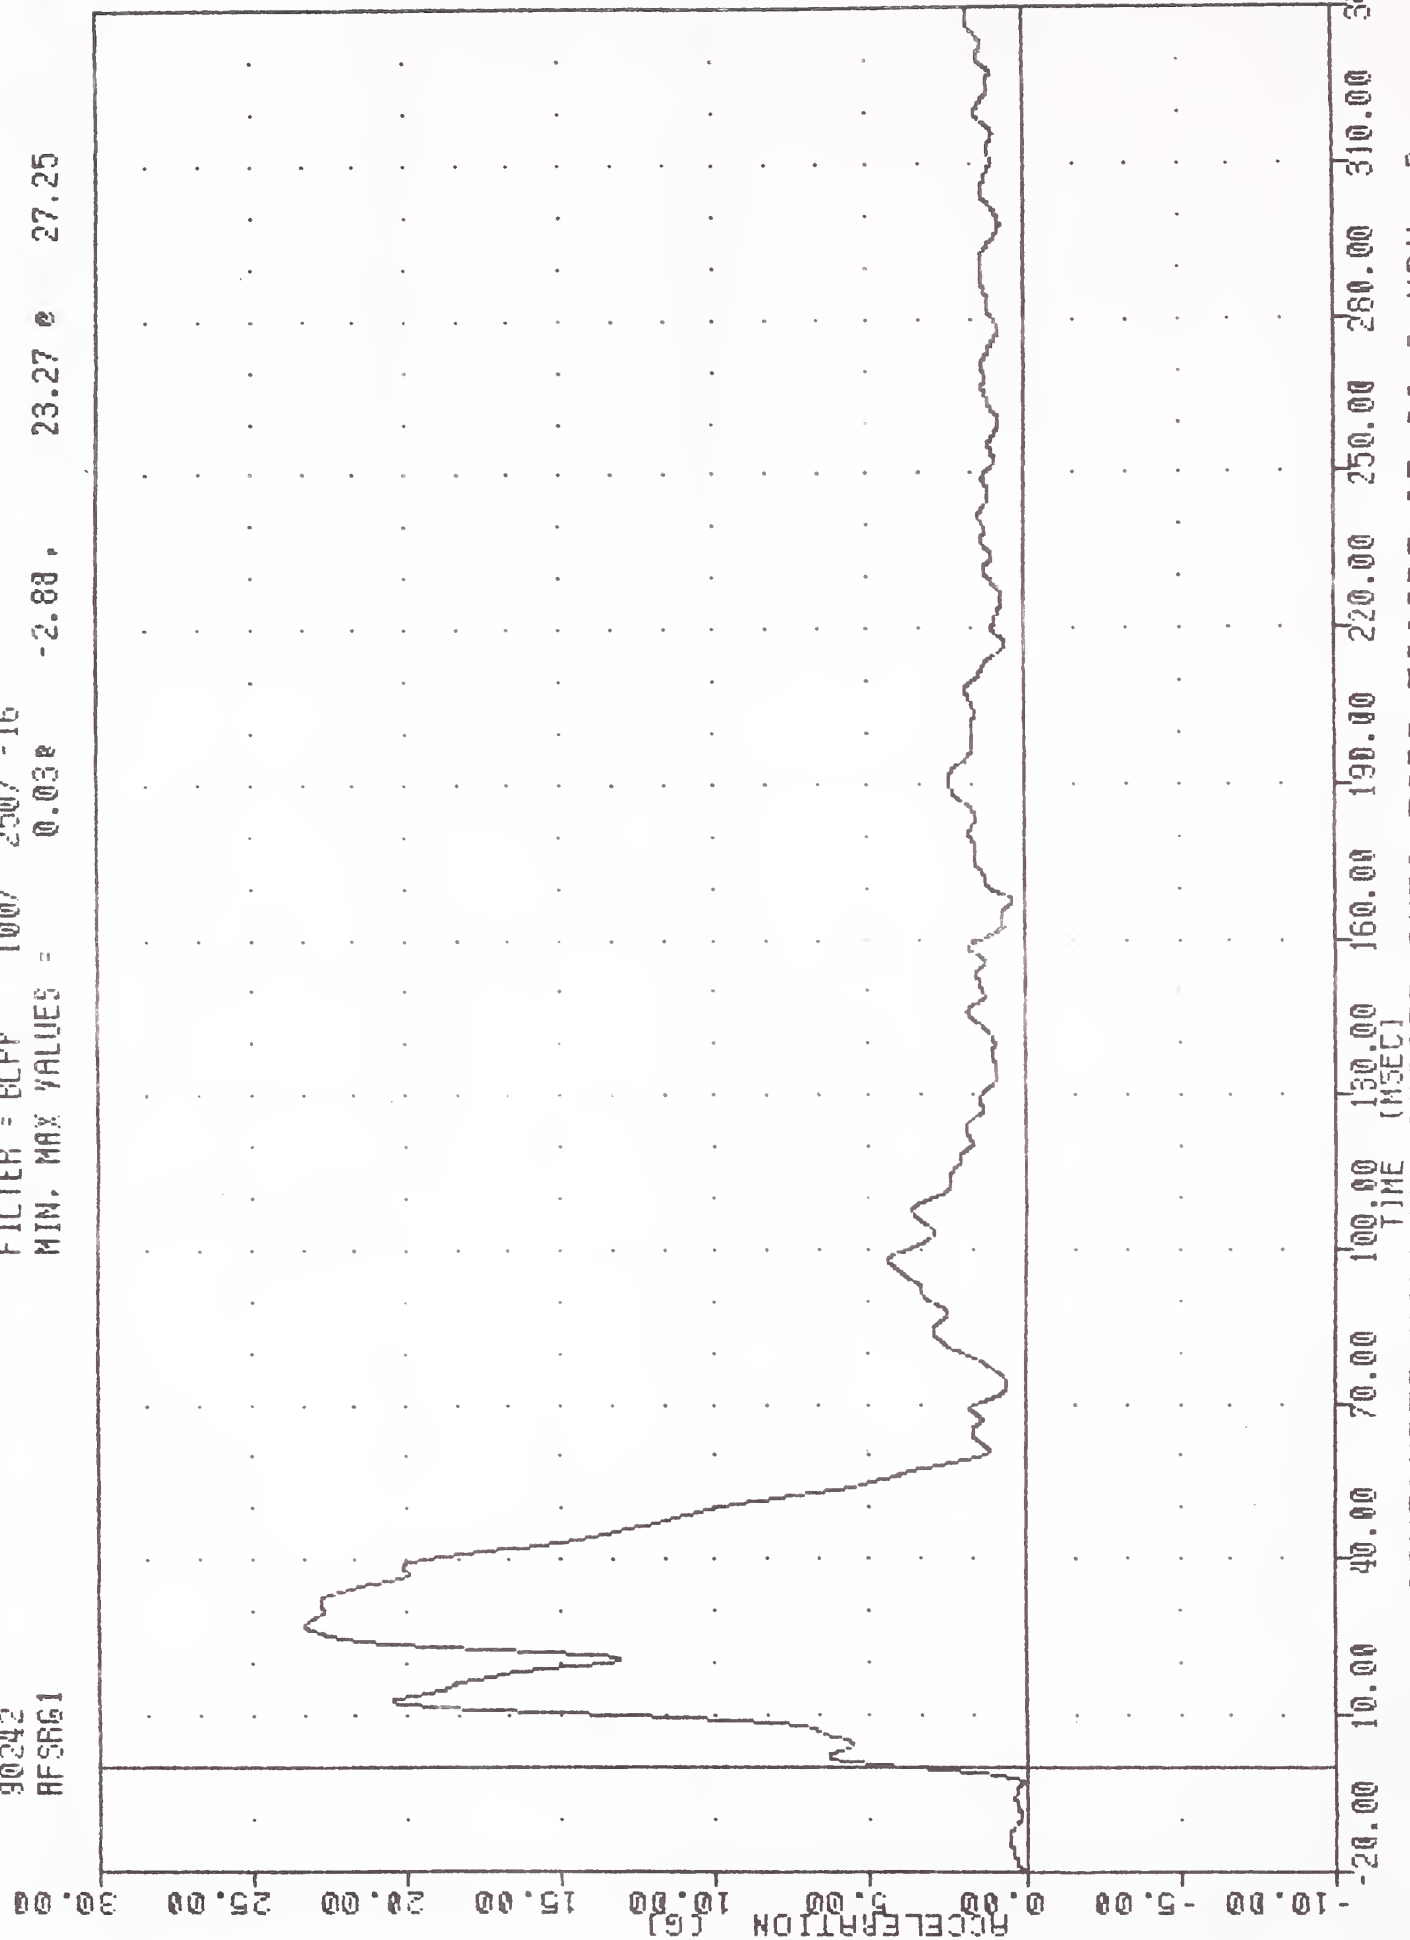
CONTOURED MOVING BARRIER INTO FORD ESCORT AT 28.3 MPH #3
RIGHT FRONT SILL RESULTANT ACCELERATION

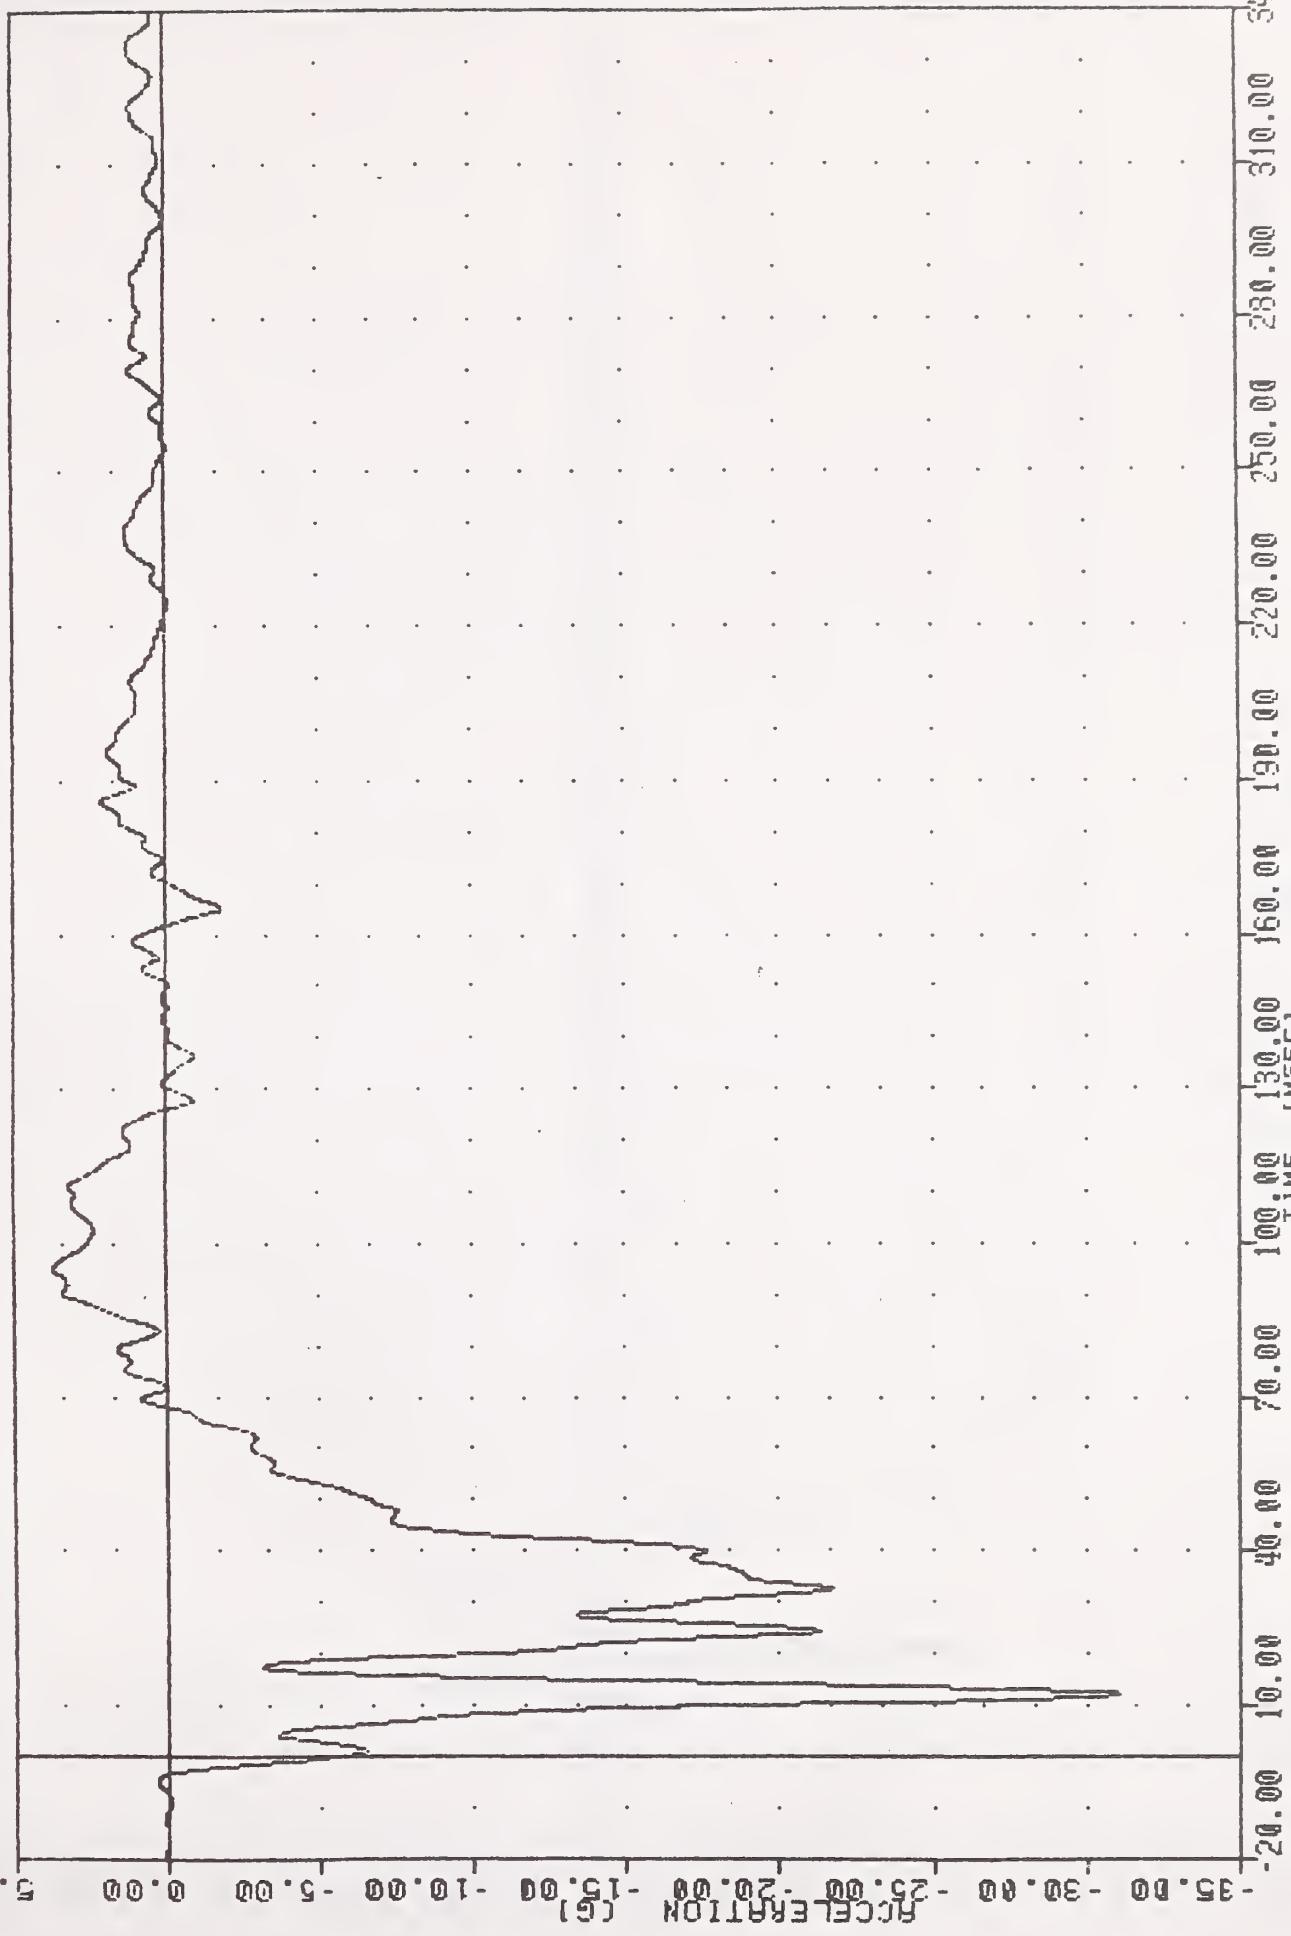
CONTOURED MOVING BARRIER INTO FORD ESCORT AT 28.3 MPH #3
 VEHICLE CG X-AXIS ACCELERATION (IMPACT DIRECTION)

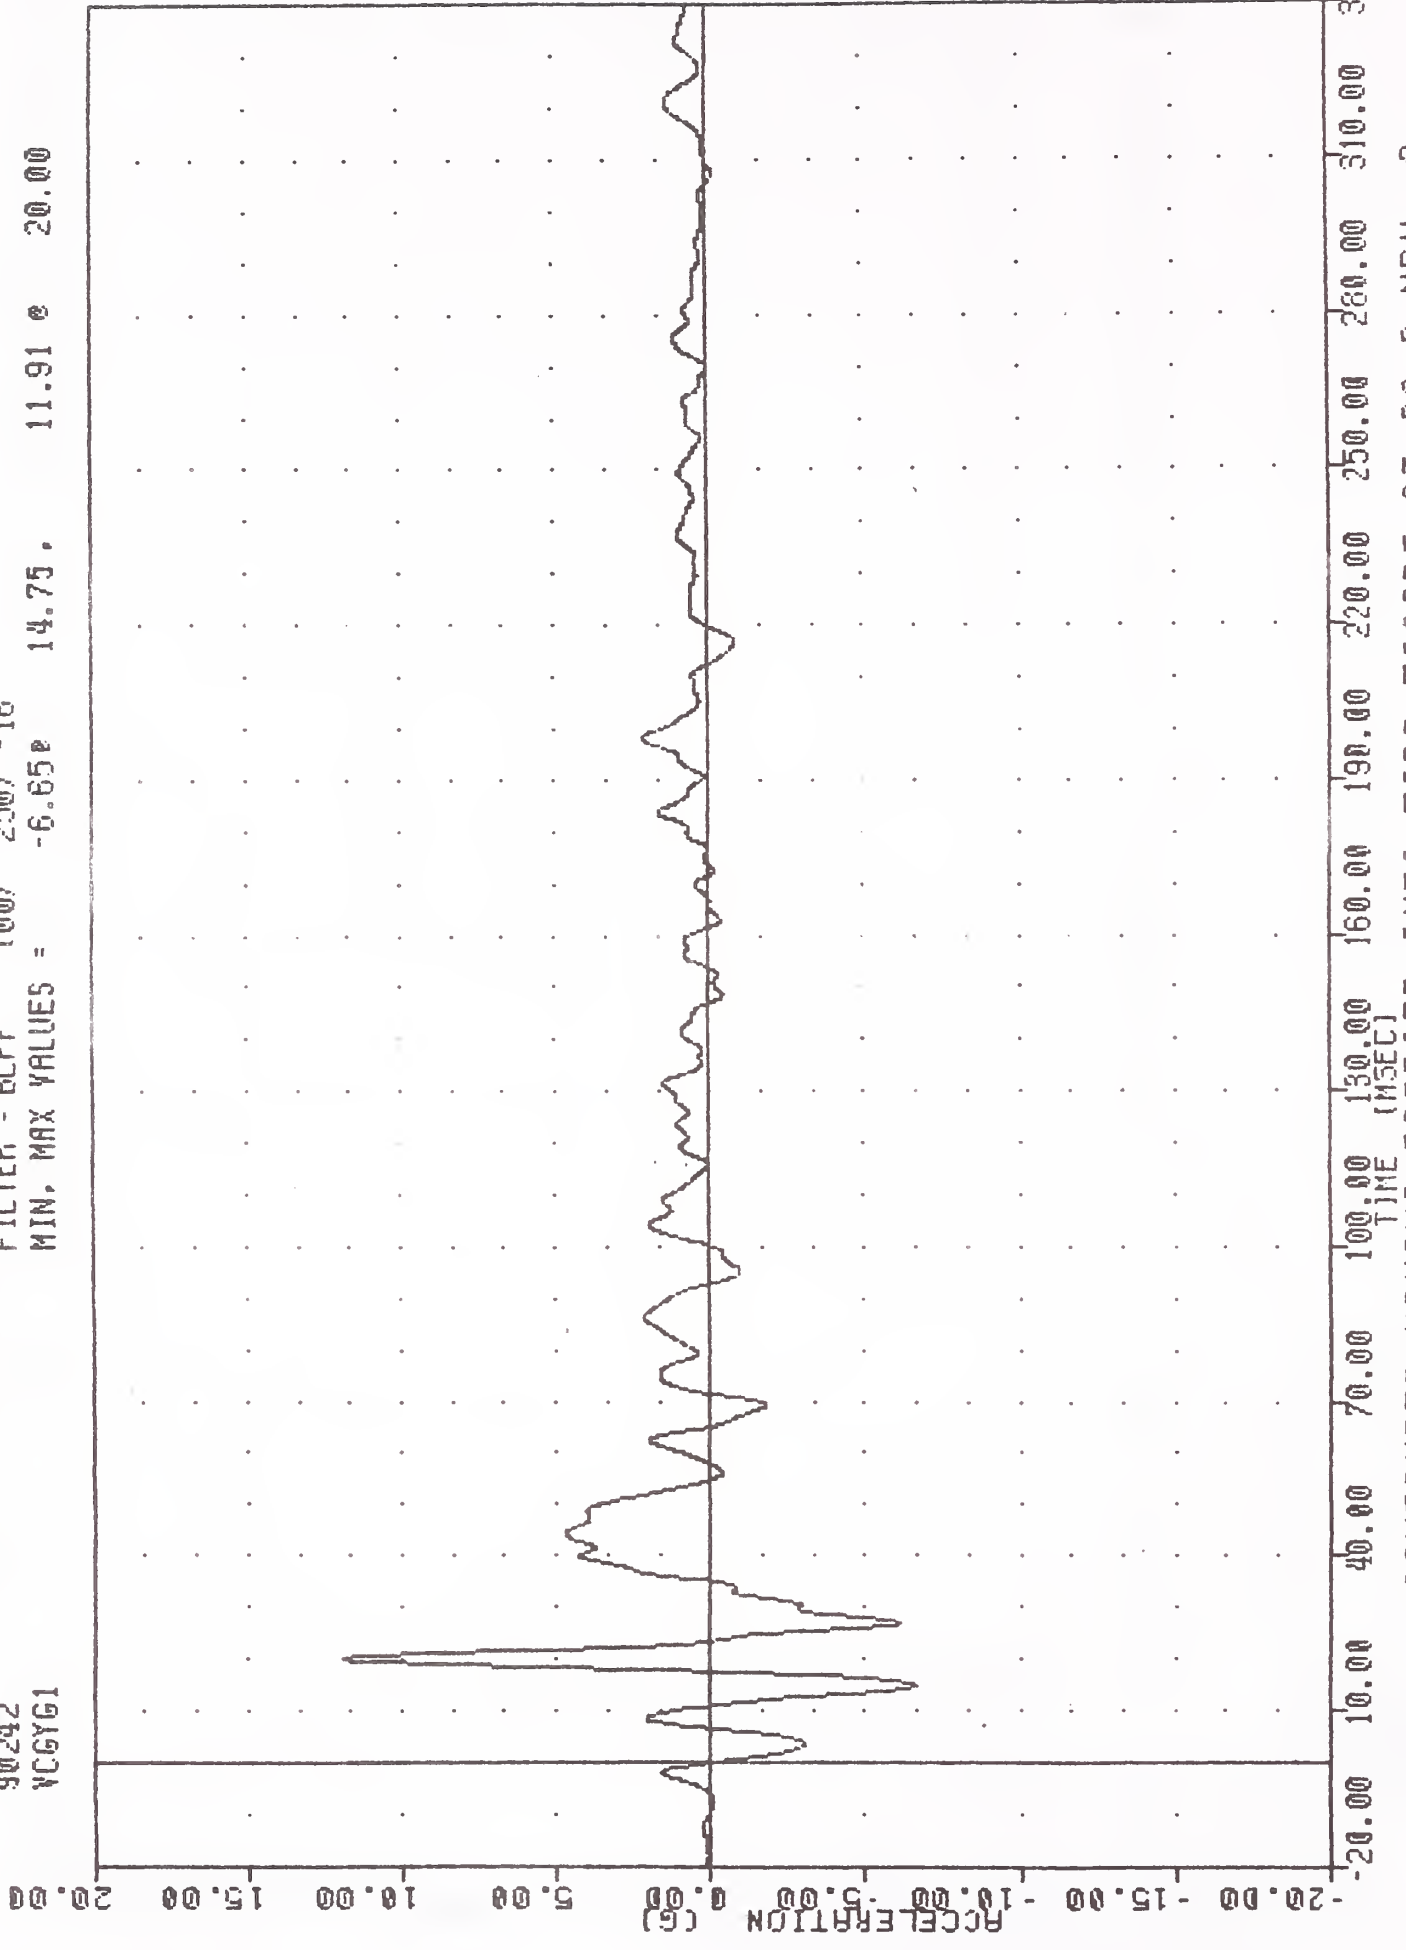
CONTOURED MOVING BARRIER INTO FORD ESCORT AT 28.3 MPH #3
 VEHICLE CG Y-AXIS ACCELERATION (PERPENDICULAR TO IMPACT DIRECTION)

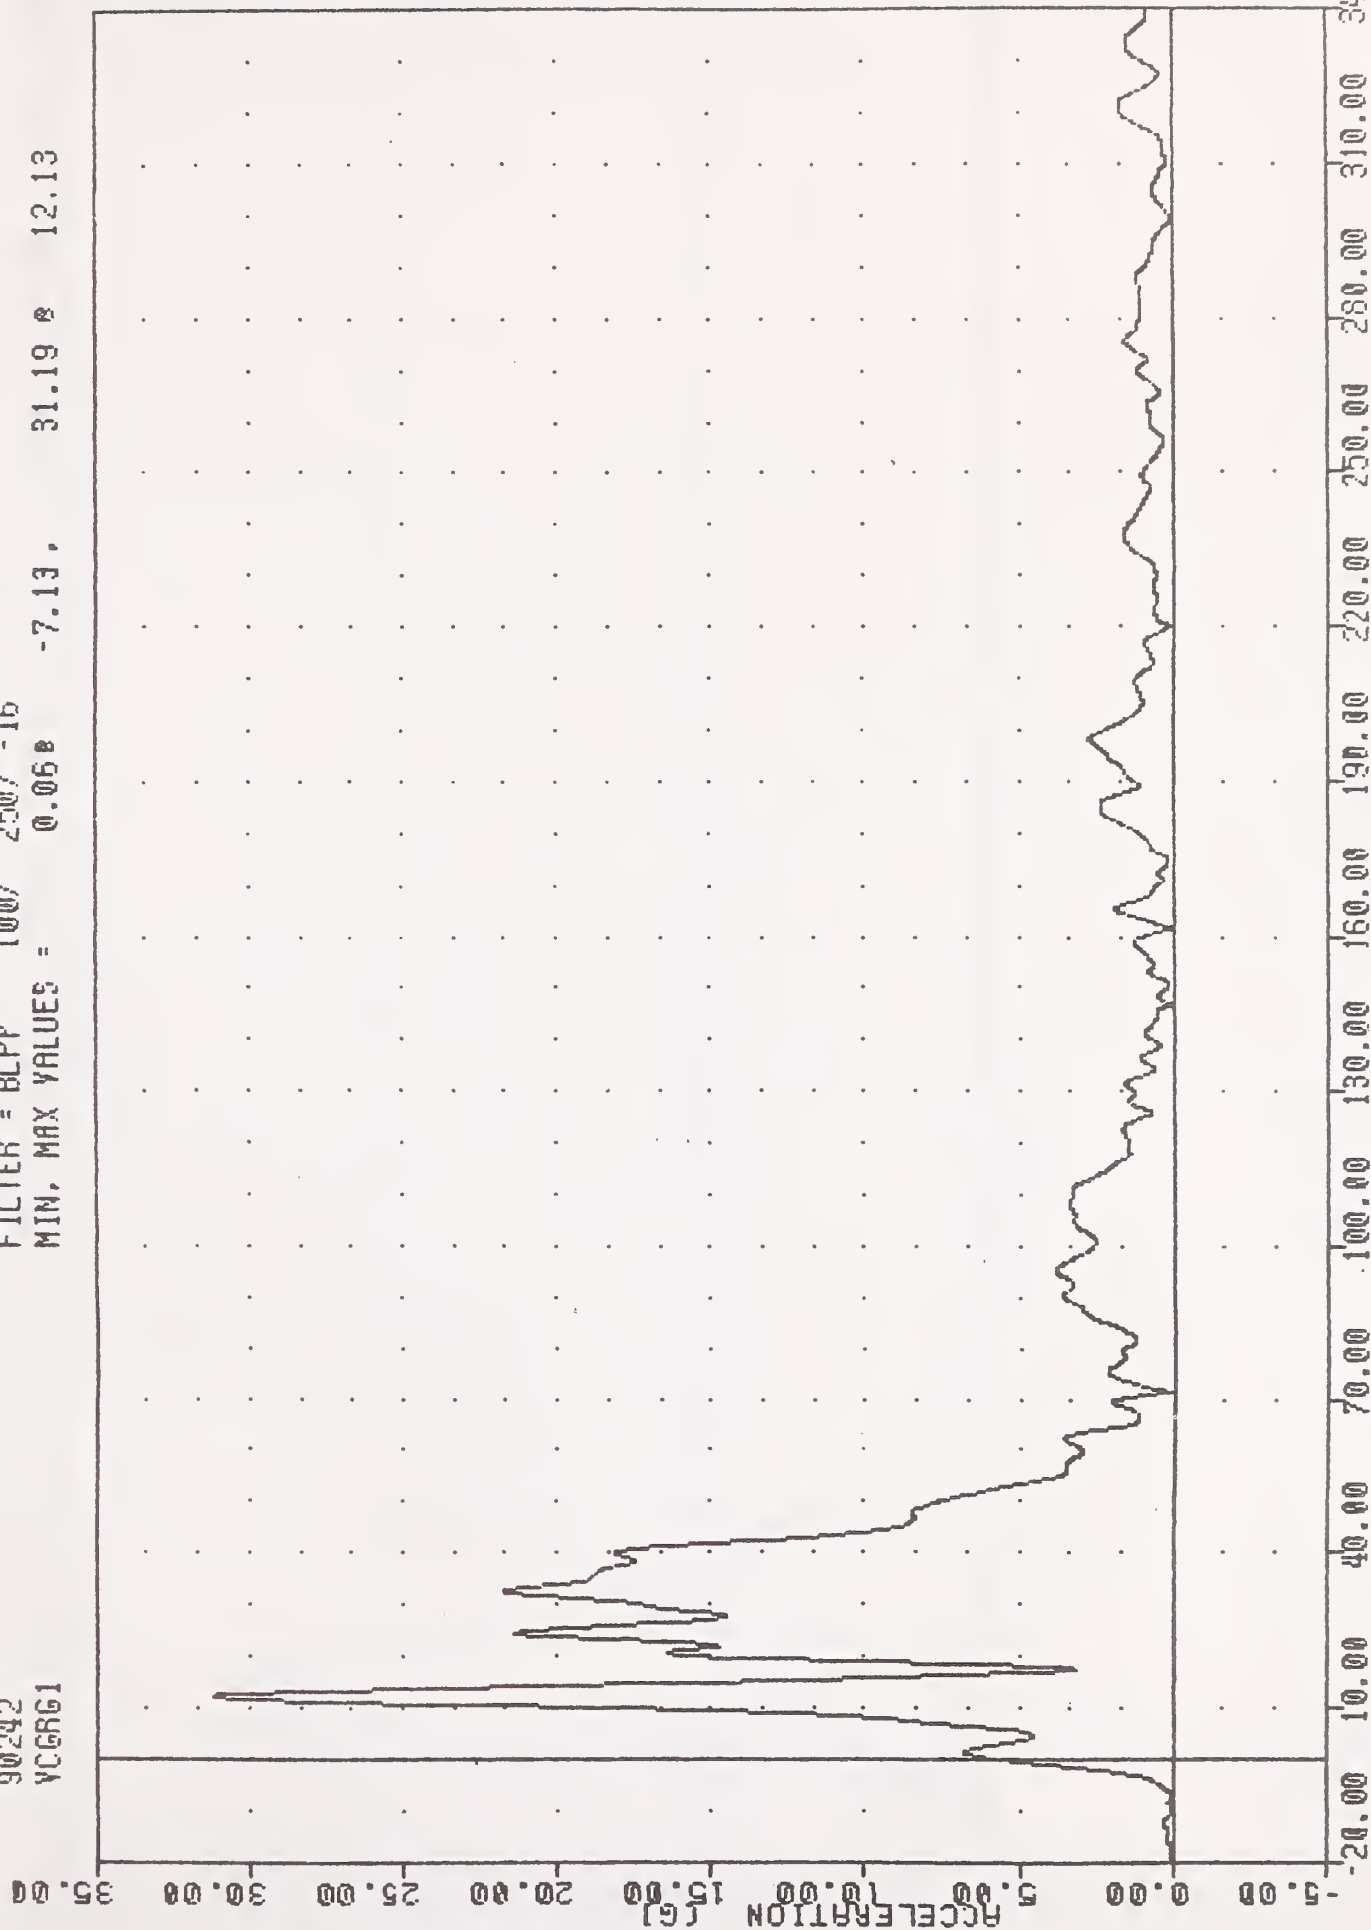
CONTOURED MOVING BARRIER INTO FORD ESCORT AT 28.3 MPH #3
 VEHICLE CG RESULTANT ACCELERATION

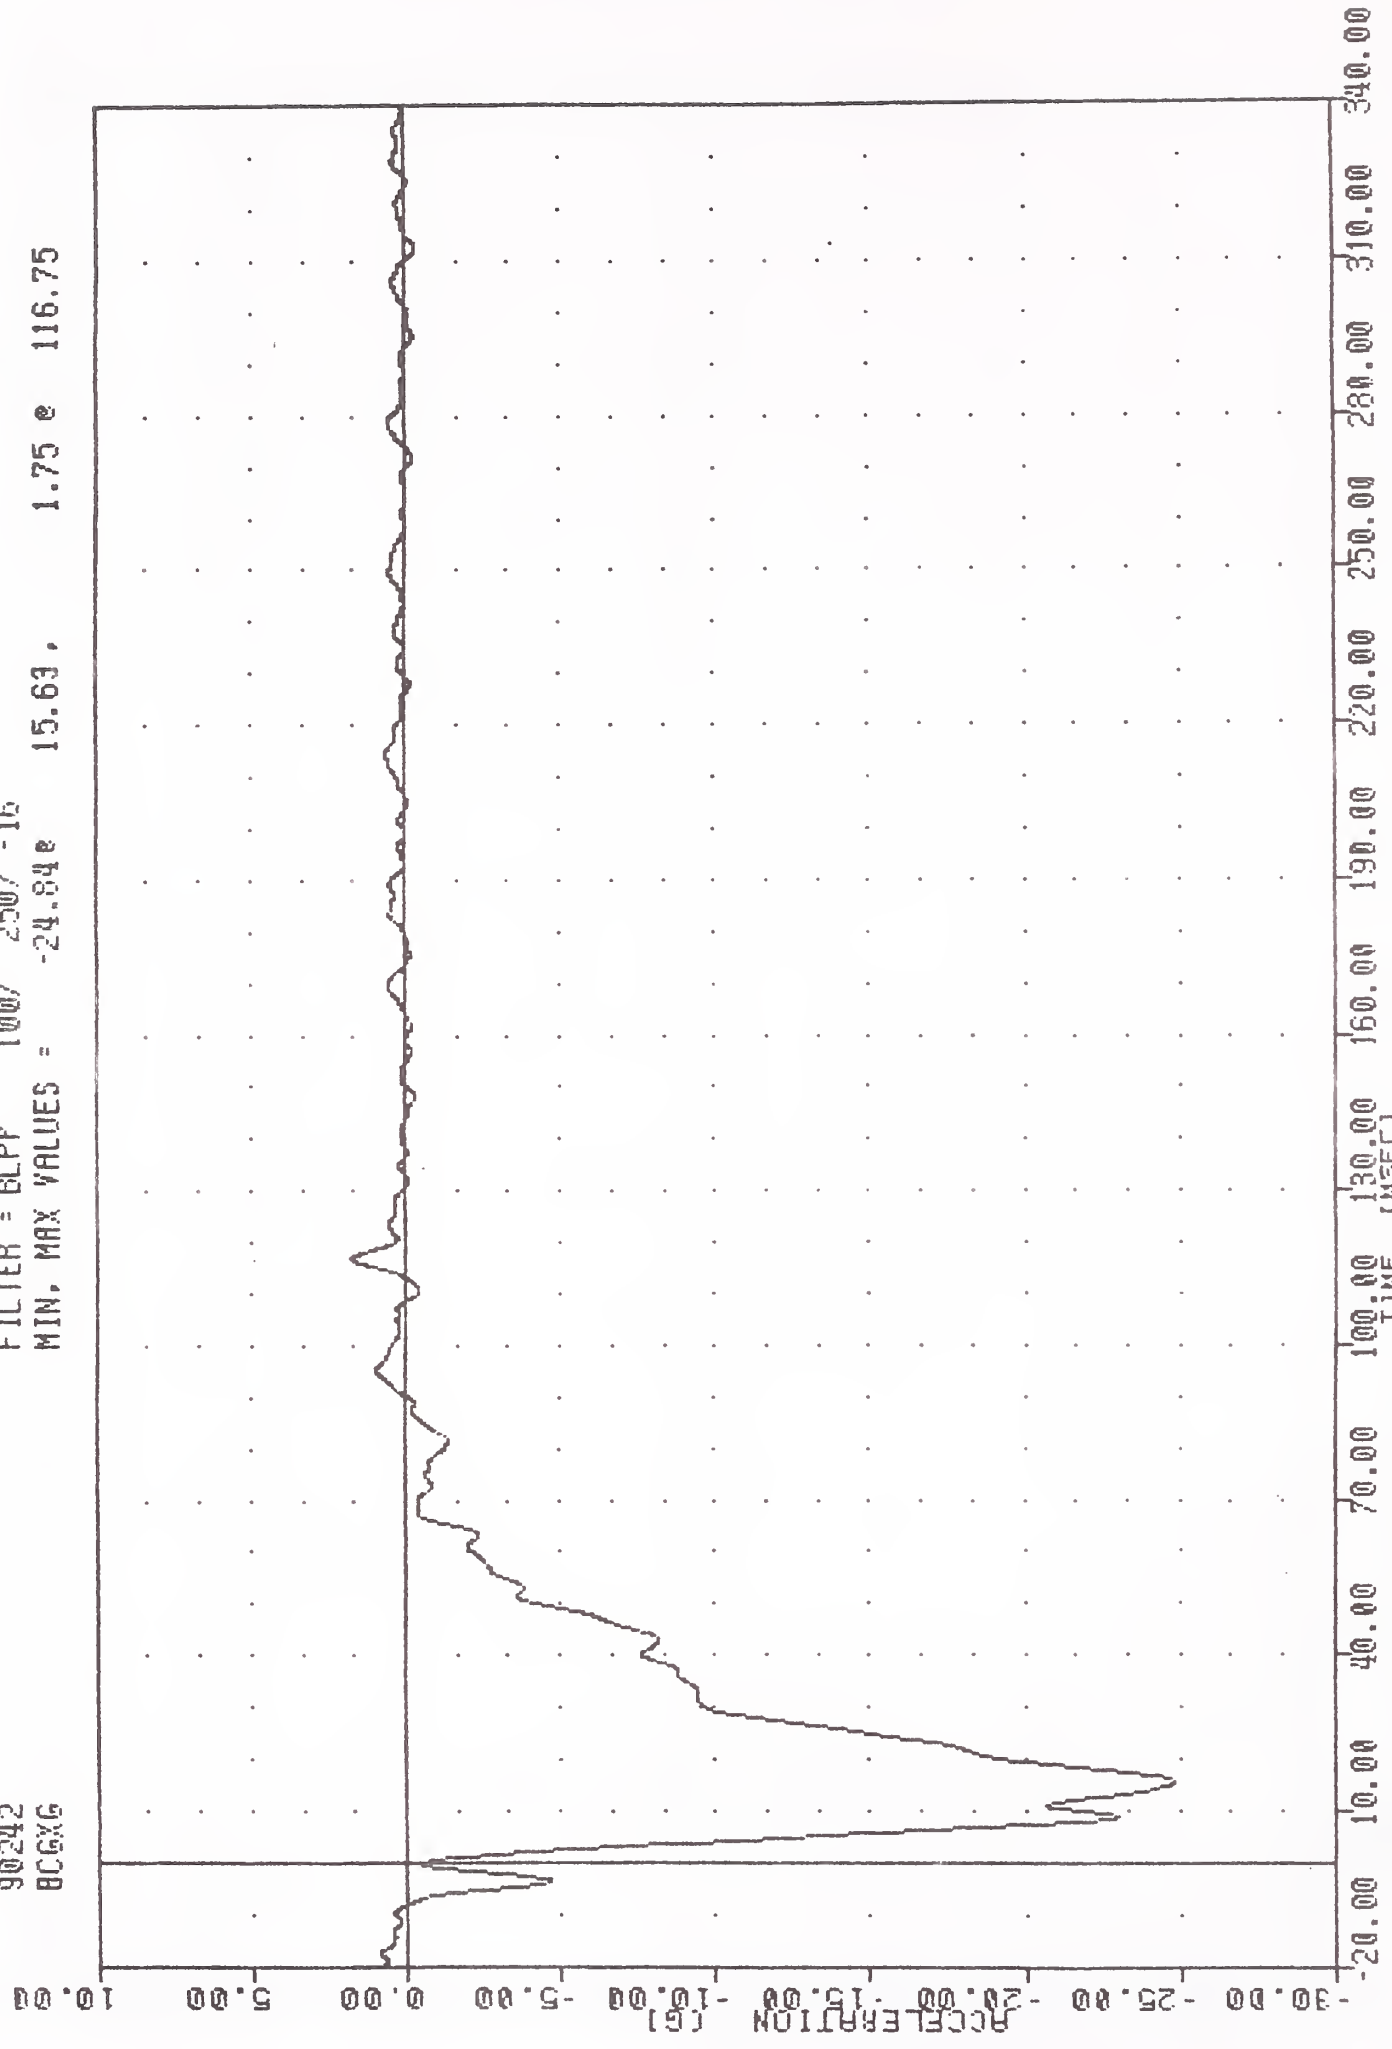
CONTOURED MOVING BARRIER INTO FORD ESCORT AT 28.3 MPH #3
MOVING BARRIER CENTER OF GRAVITY X-AXIS ACCELERATION

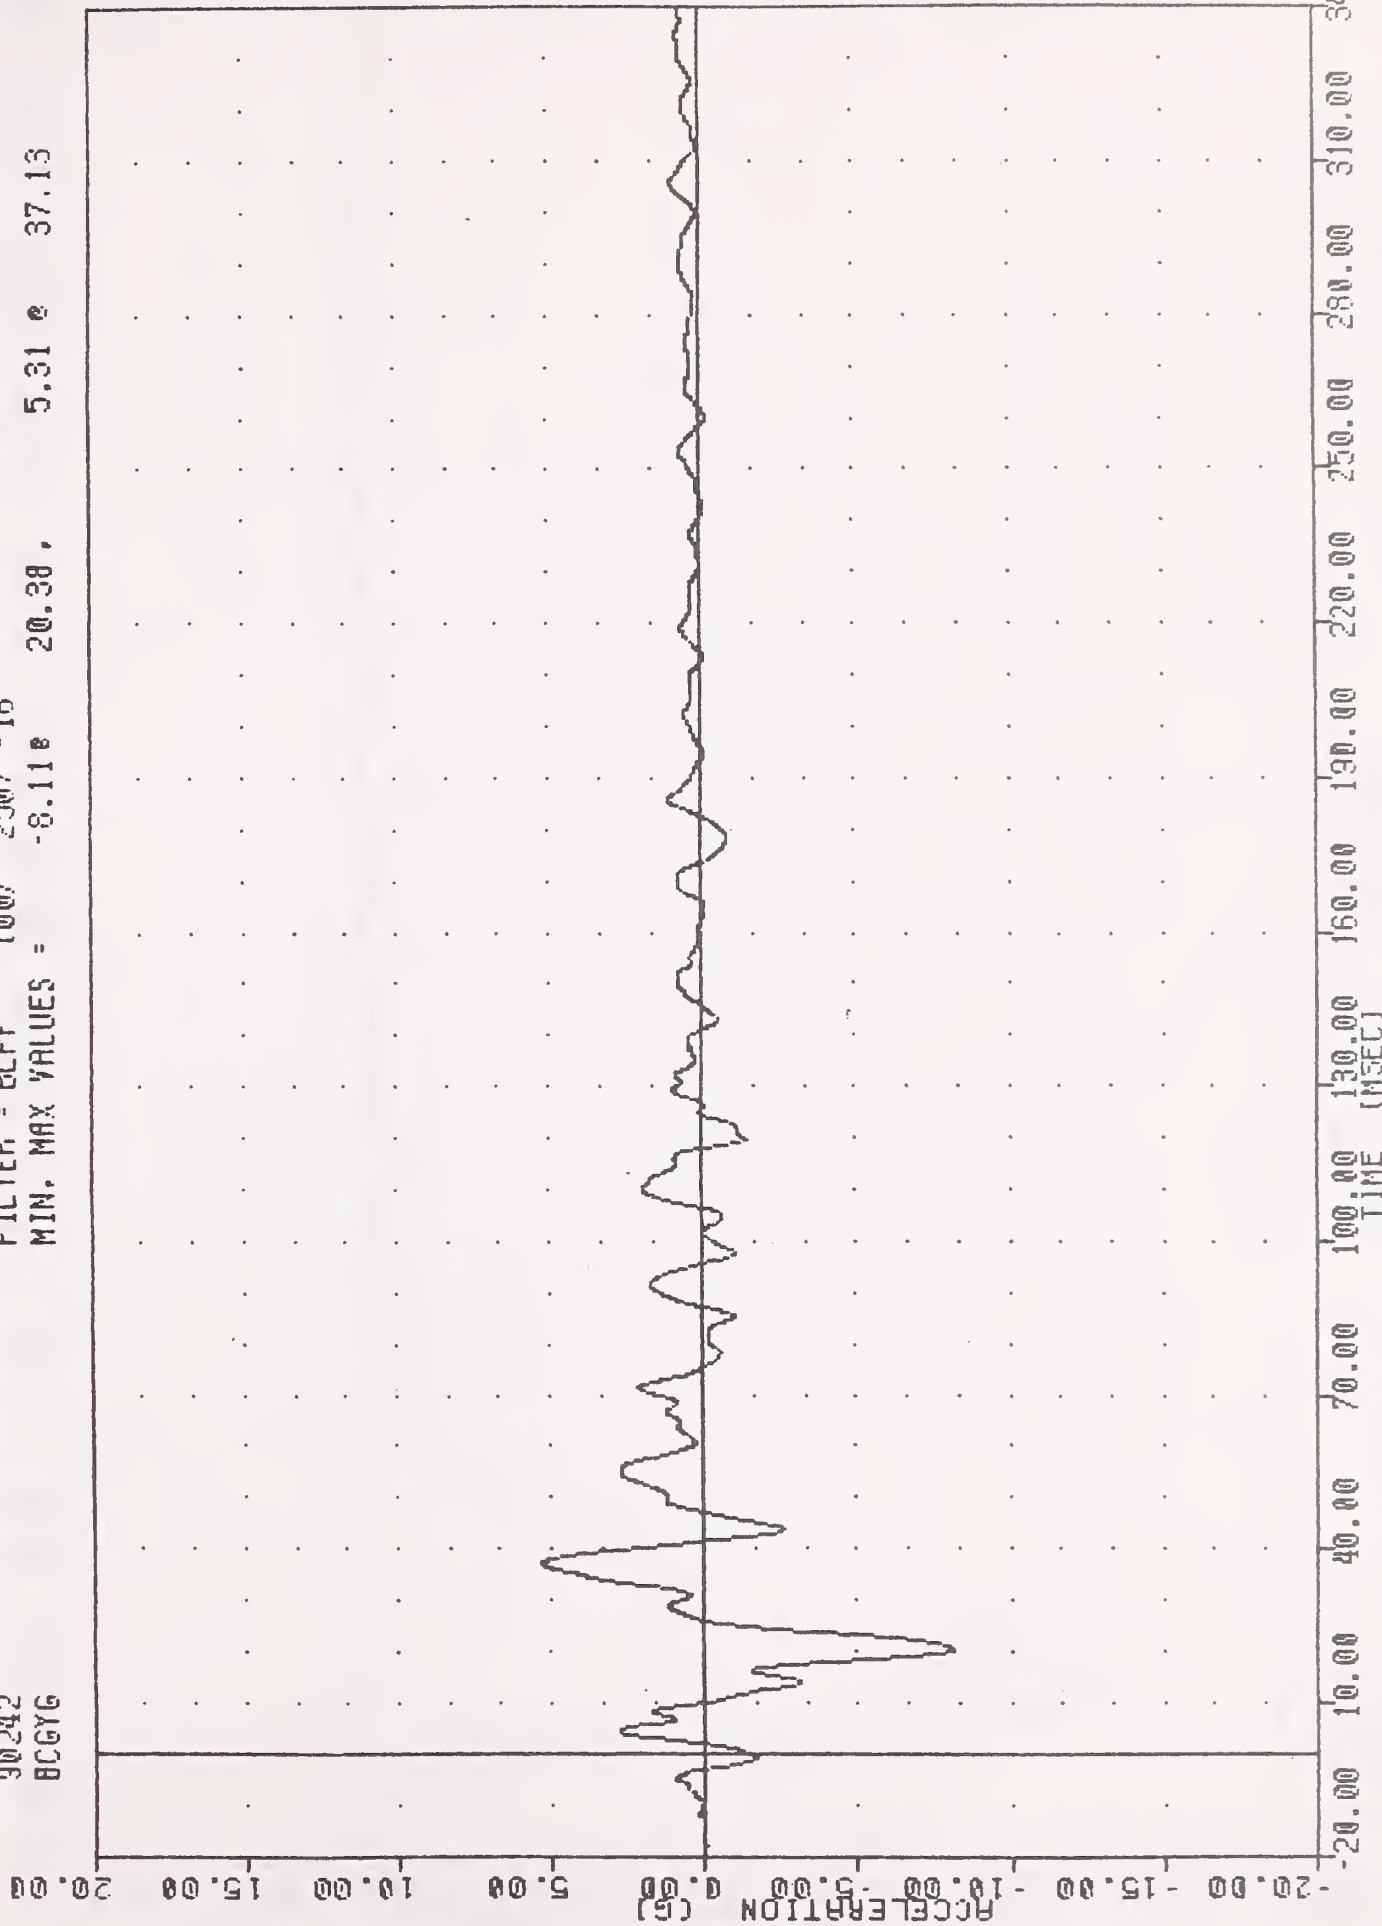
CONTOURED MOVING BARRIER INTO FORD ESCORT AT 28.3 MPH #3
MOVING BARRIER CENTER OF GRAVITY Y-AXIS ACCELERATION

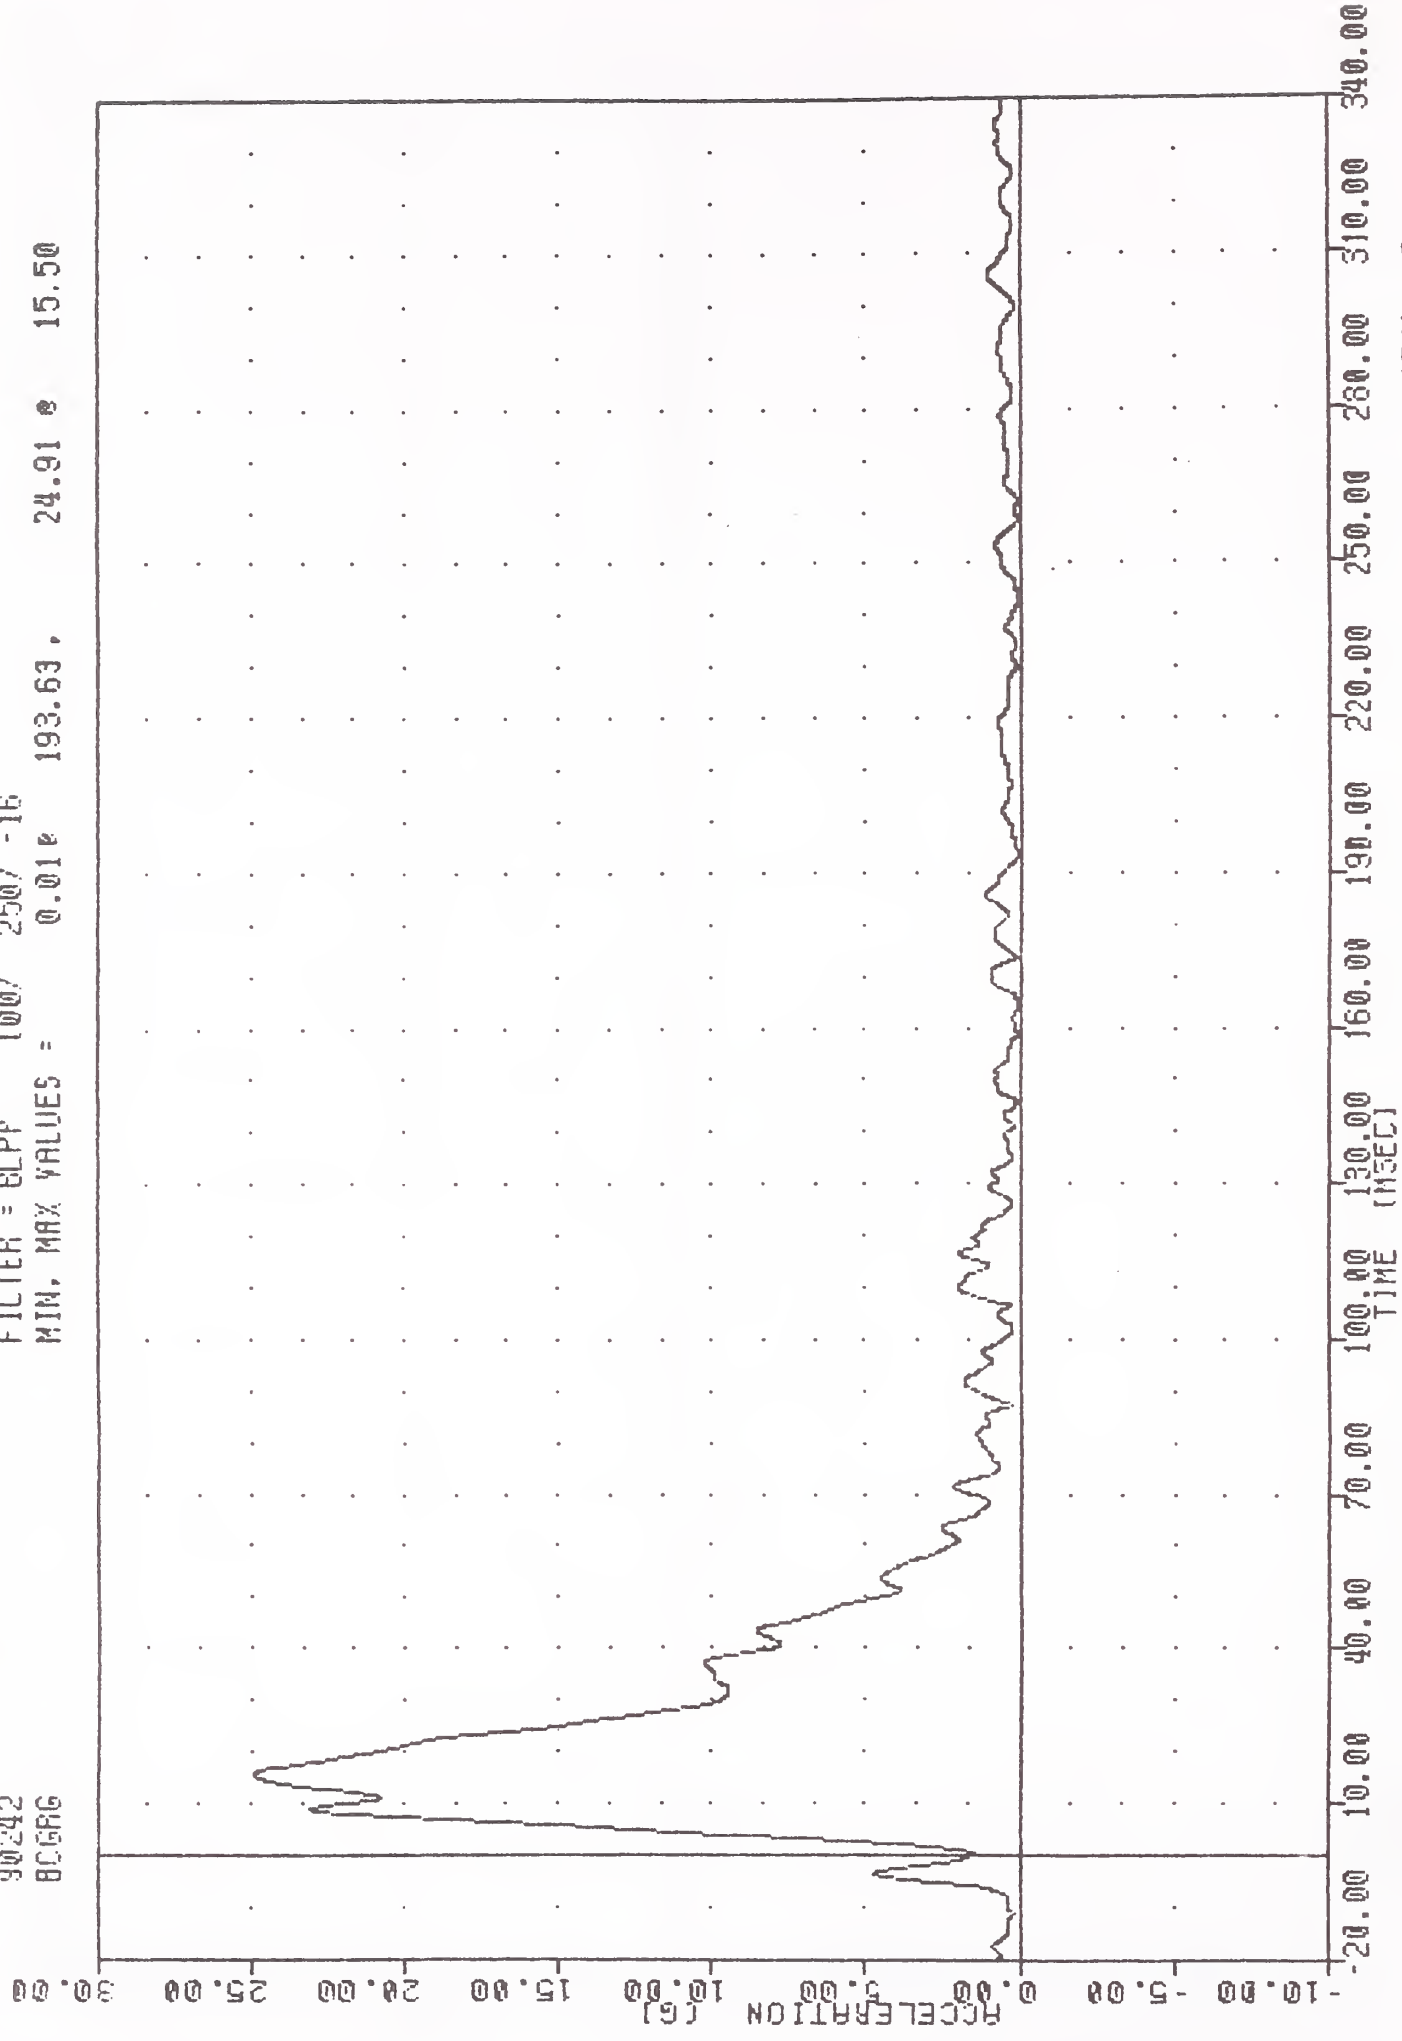
CONTOURED MOVING BARRIER INTO FORD ESCORT AT 28.3 MPH #3
 MOVING BARRIER CENTER OF GRAVITY RESULTANT ACCELERATION

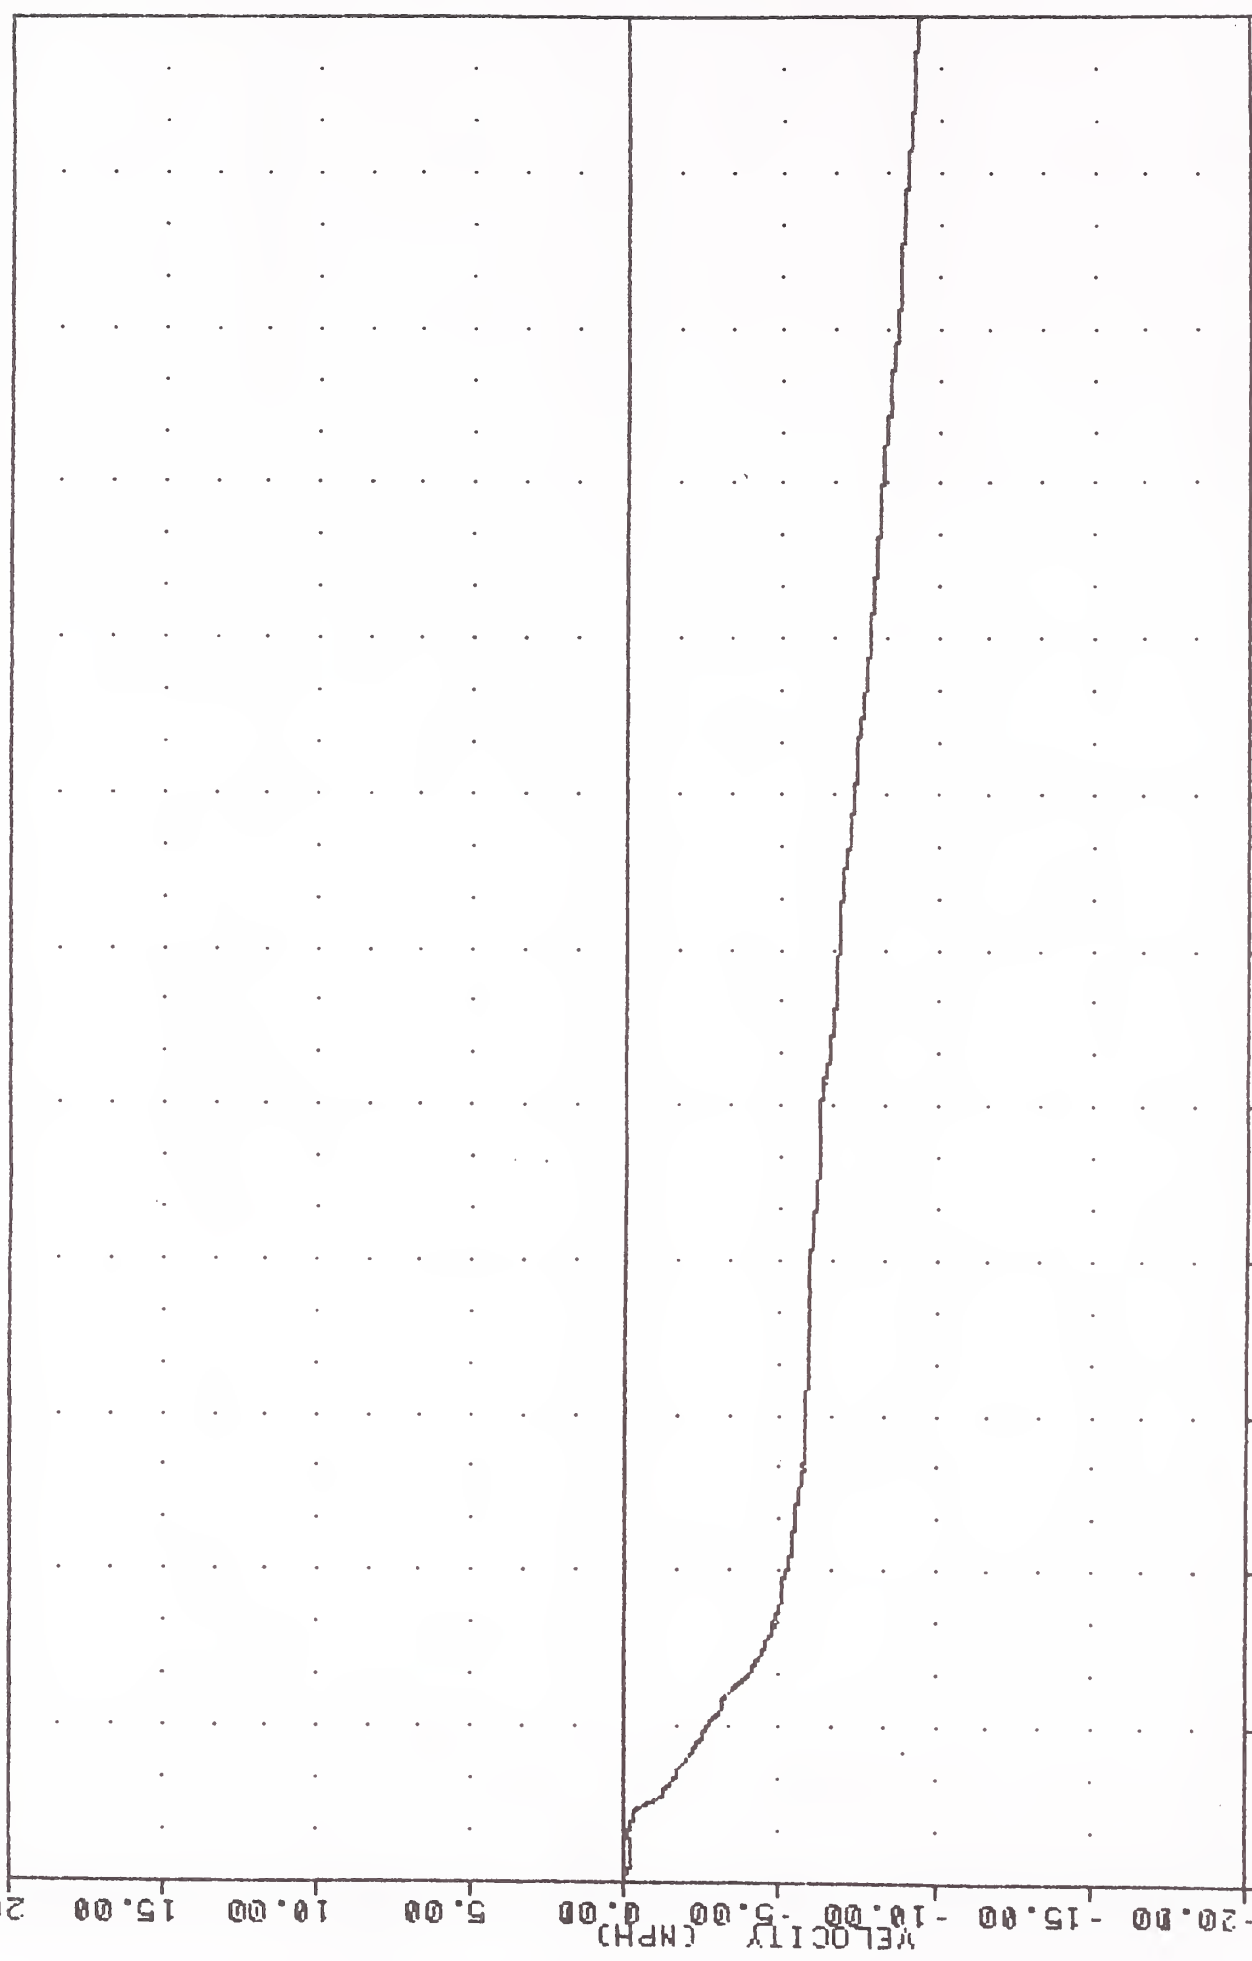
CONTOURED MOVING BARRIER INTO FORD ESCORT AT 28.3 MPH #3
 LEFT FRONT SILL Y-AXIS VELOCITY
